# RECONNAISSANCE REPORT OF DAMAGE TO HISTORIC MONUMENTS IN CAIRO, EGYPT FOLLOWING THE OCTOBER 12, 1992 DAHSHUR EARTHQUAKE

**Reconnaissance Report of Damage  
to Historic Monuments in Cairo, Egypt  
Following the October 12, 1992 Dahshur Earthquake**

Technical Report NCEER-93-0016

August 19, 1993

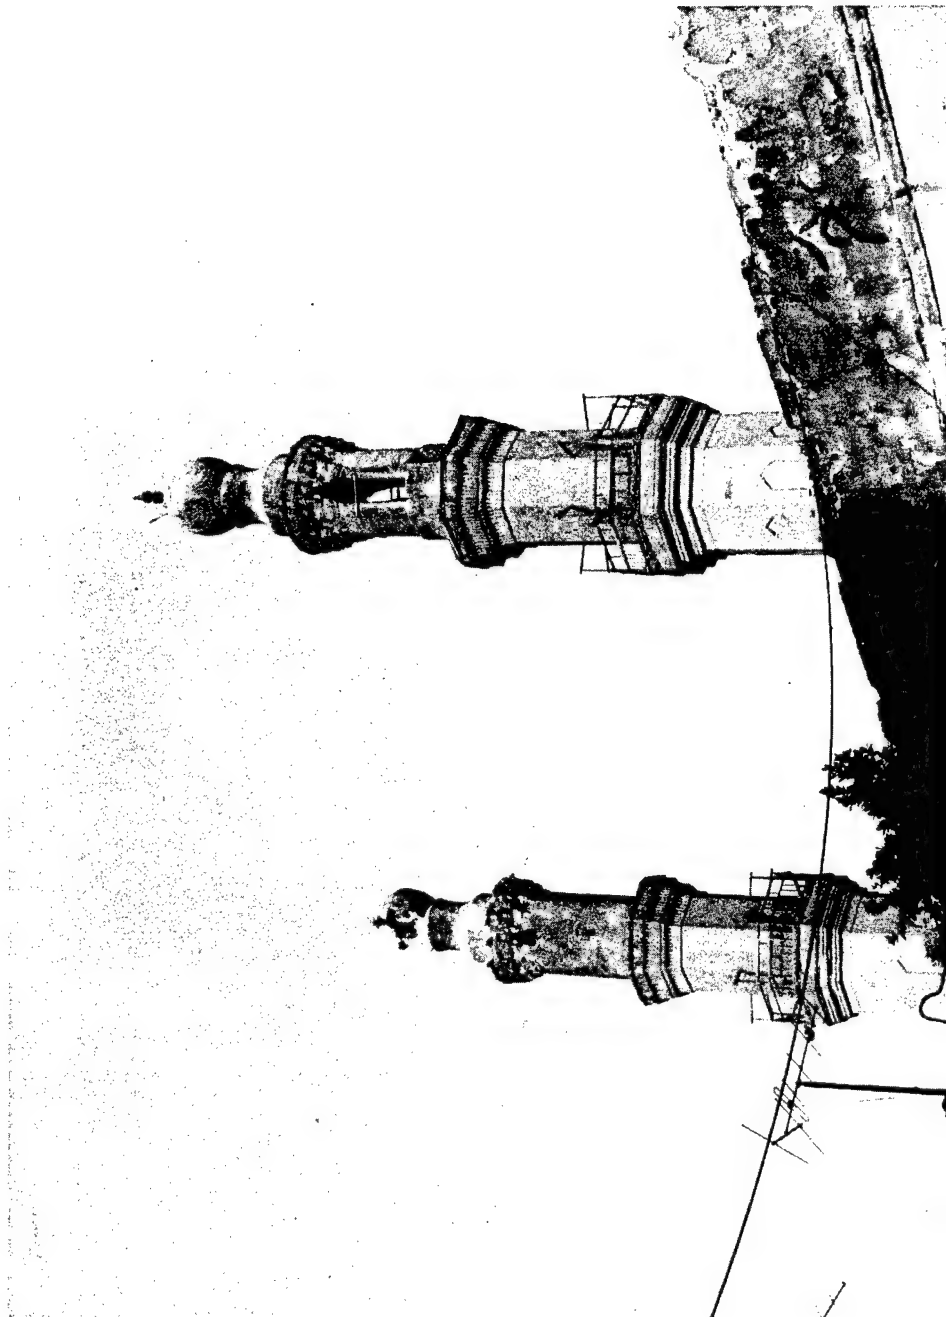
**FIGURE 4-26** Minarets of the Mosque of Amir Shaykhū (left) and the Khanqāh of Amir Shaykhū (right) showing damage to the bulb at the mosque

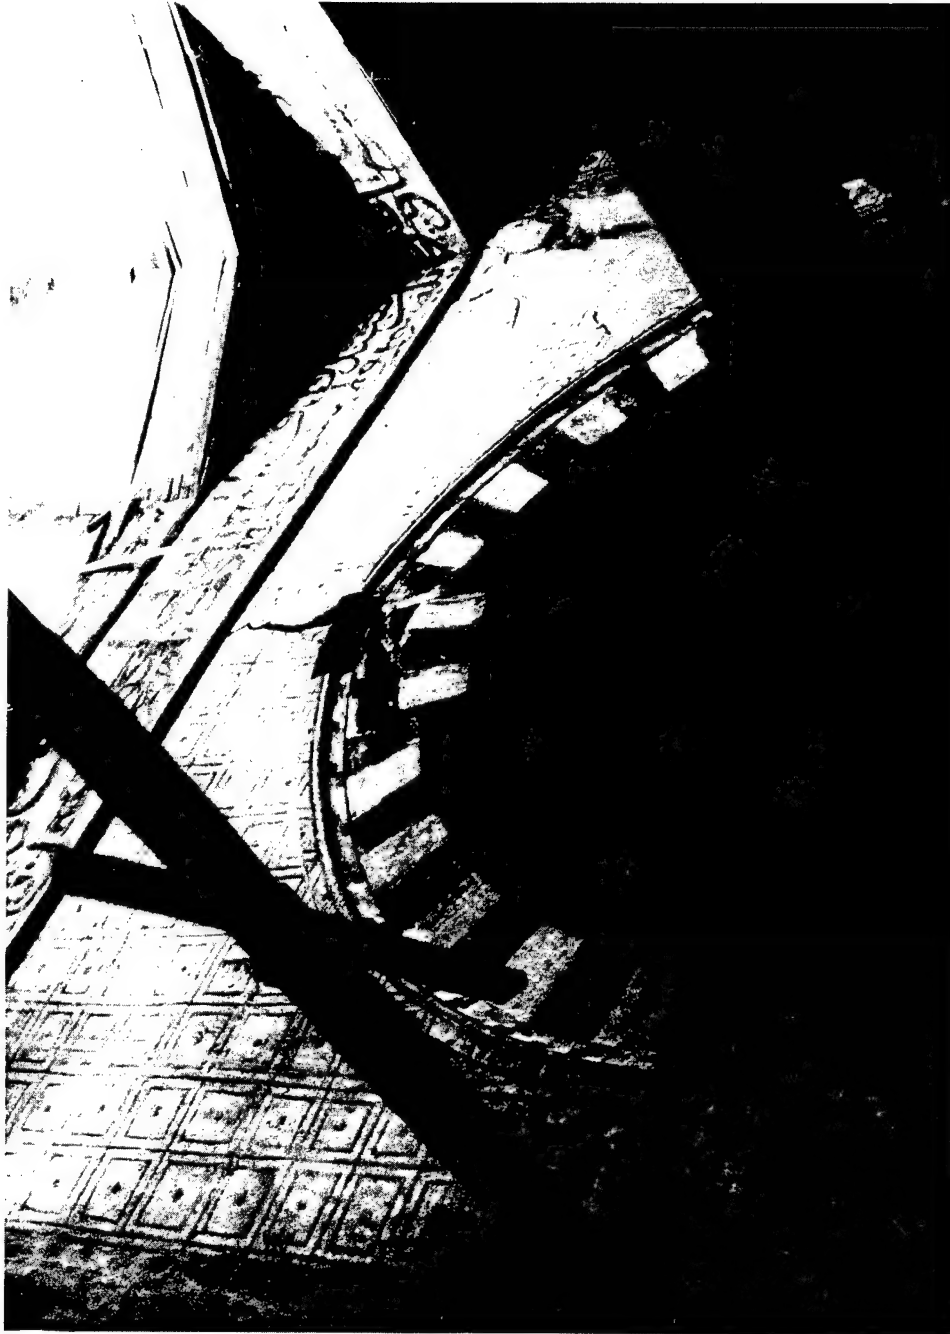
**FIGURE 4-27** Arch on the west side of the northwest corner at the Khanqāh of Amir Shaykhū showing downdrop of keystone and two flanking voussoirs

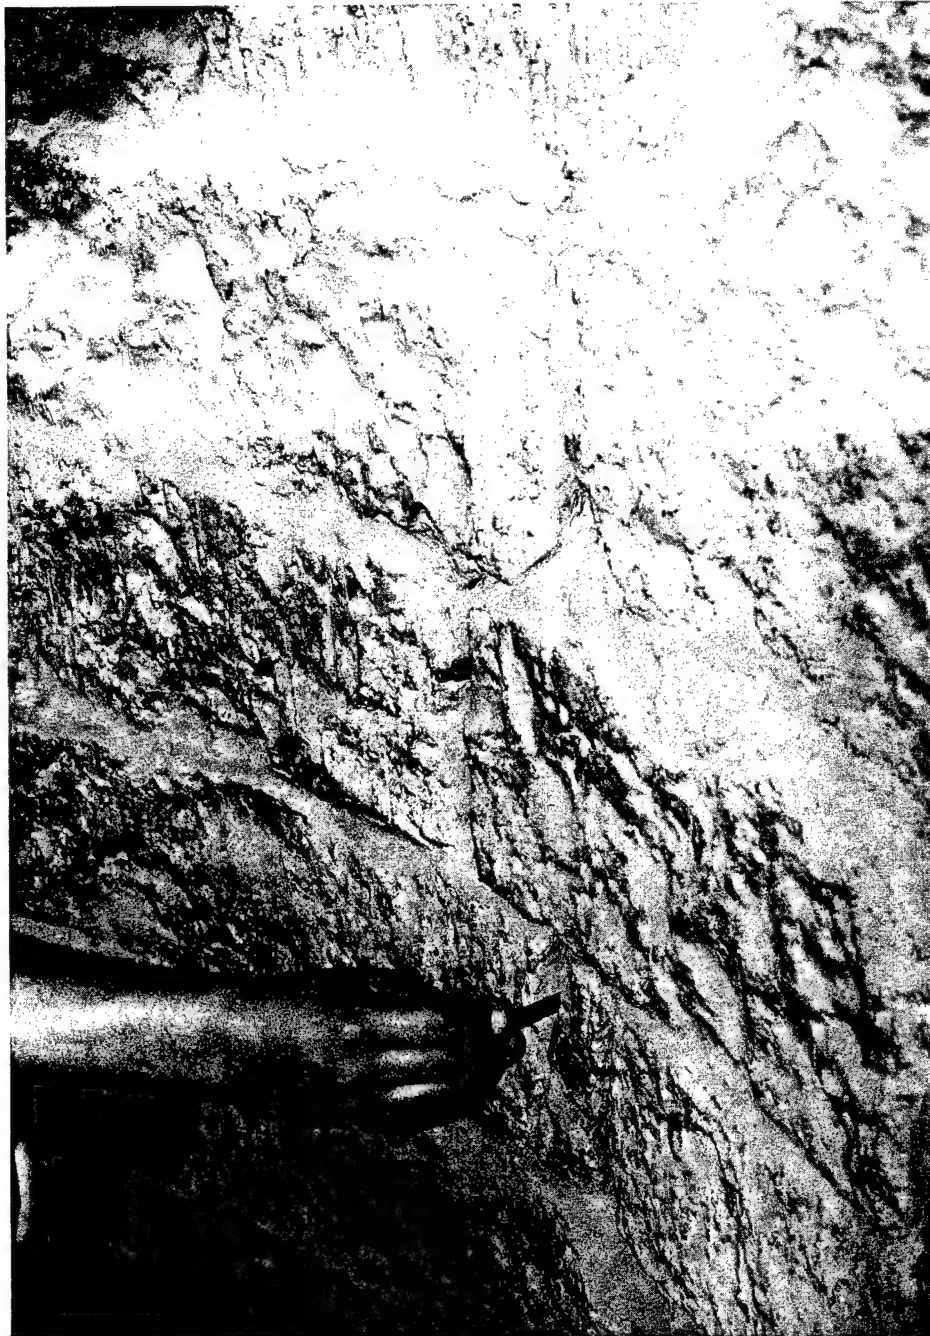
**FIGURE 4-29** Interior of southern minaret wall at Mosque, Mausoleum, and Madrasa of Sultân Hasan showing large vertical crack

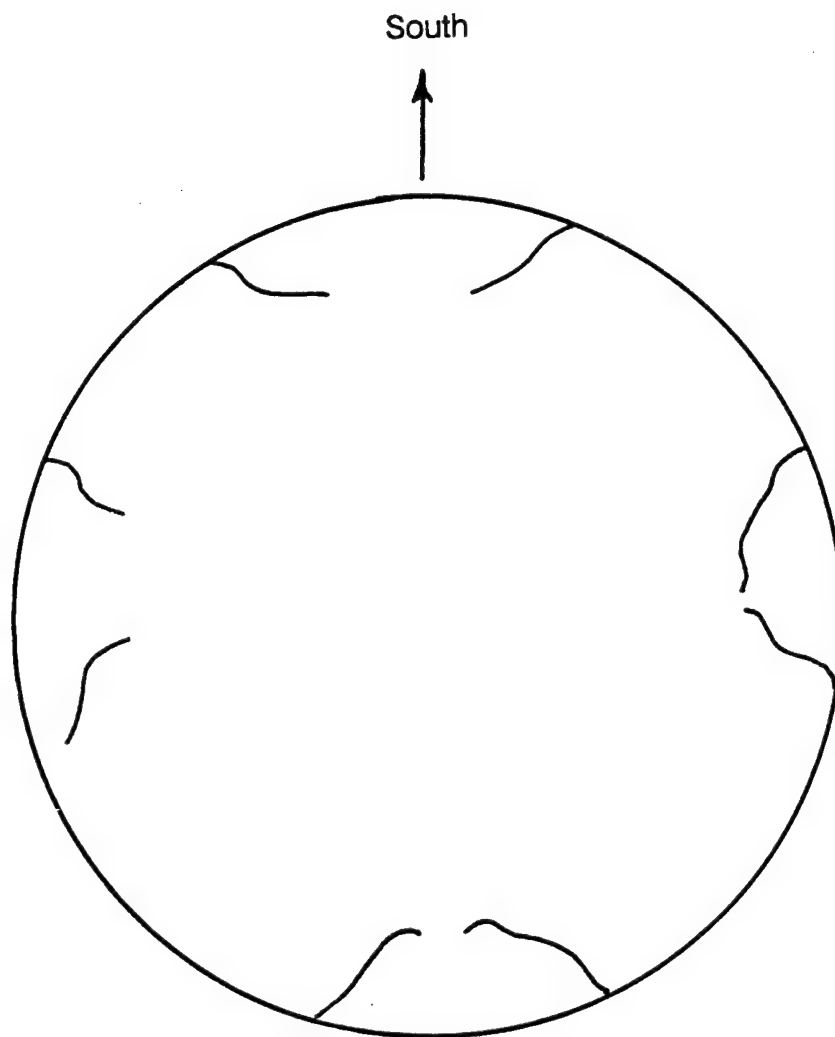
**FIGURE 4-30** Sketch of interior crack pattern in dome of Mausoleum of Sultan Hasan looking up

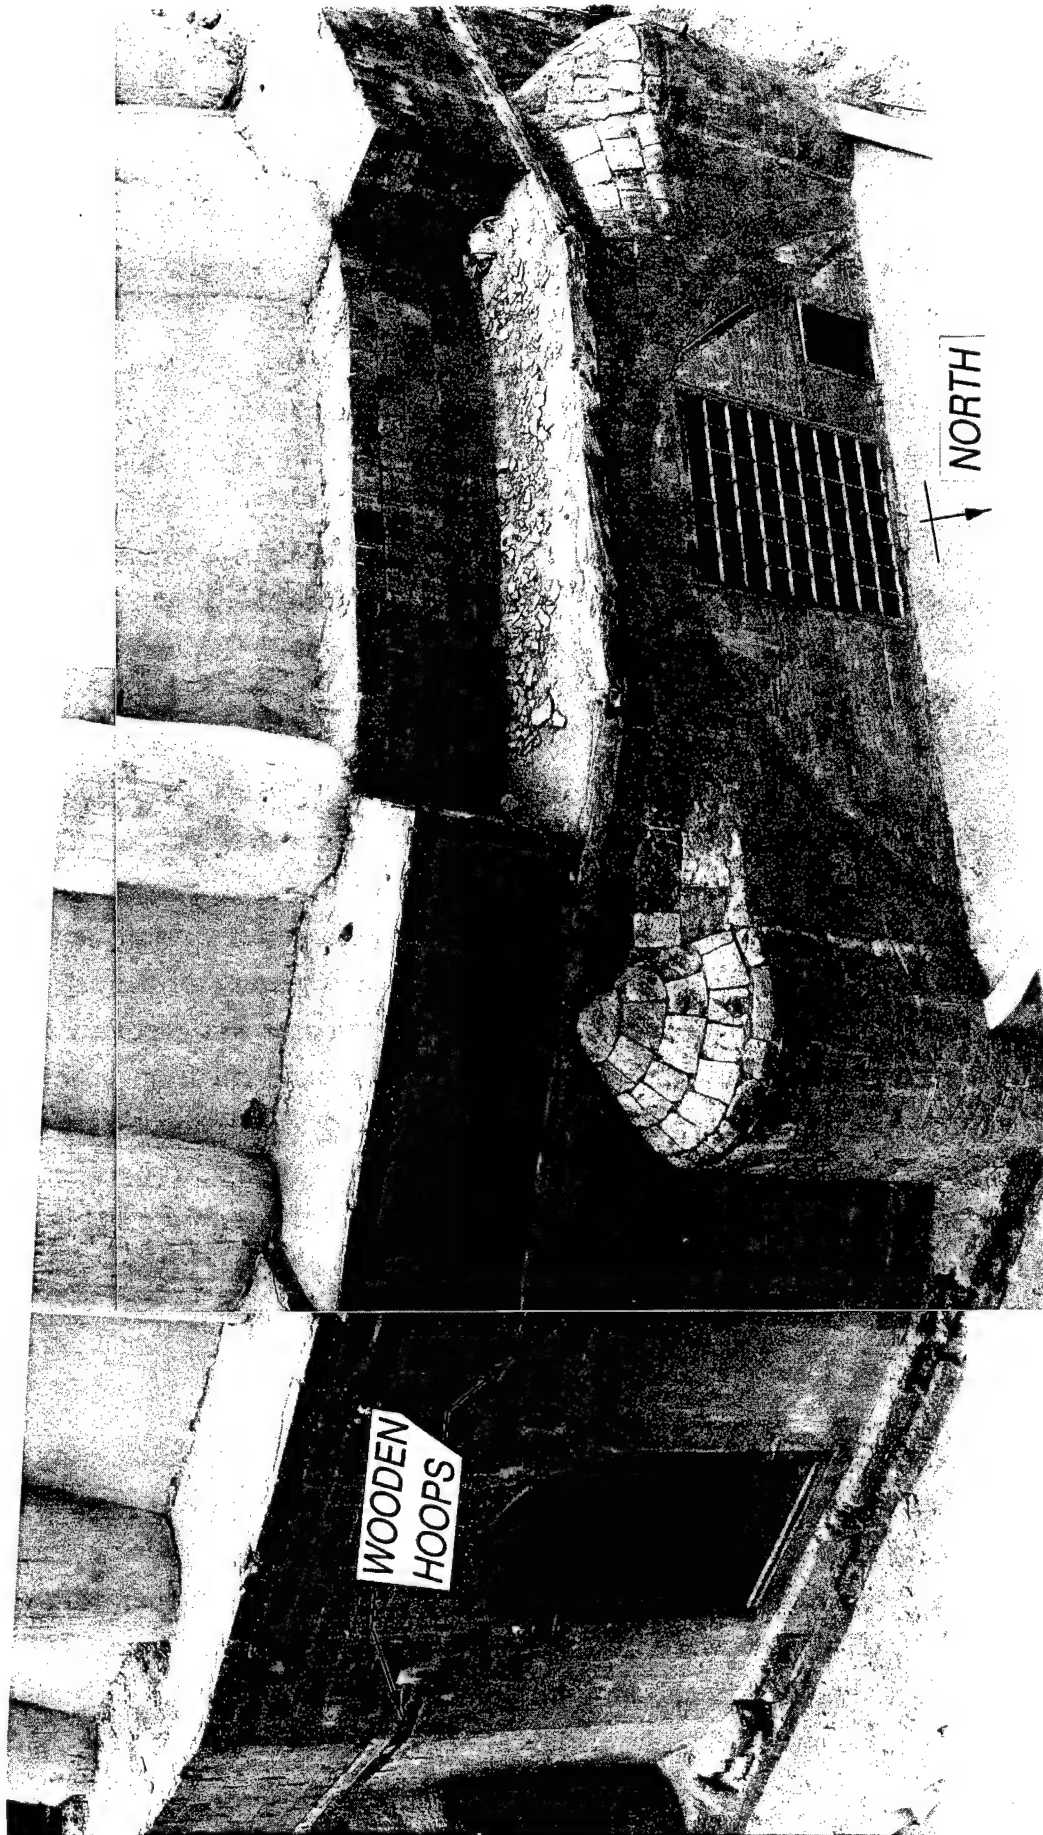
**FIGURE 4-31** Exterior of major dome at Mausoleum of Sultān Hasan looking south  
showing wooden hoop structural support system

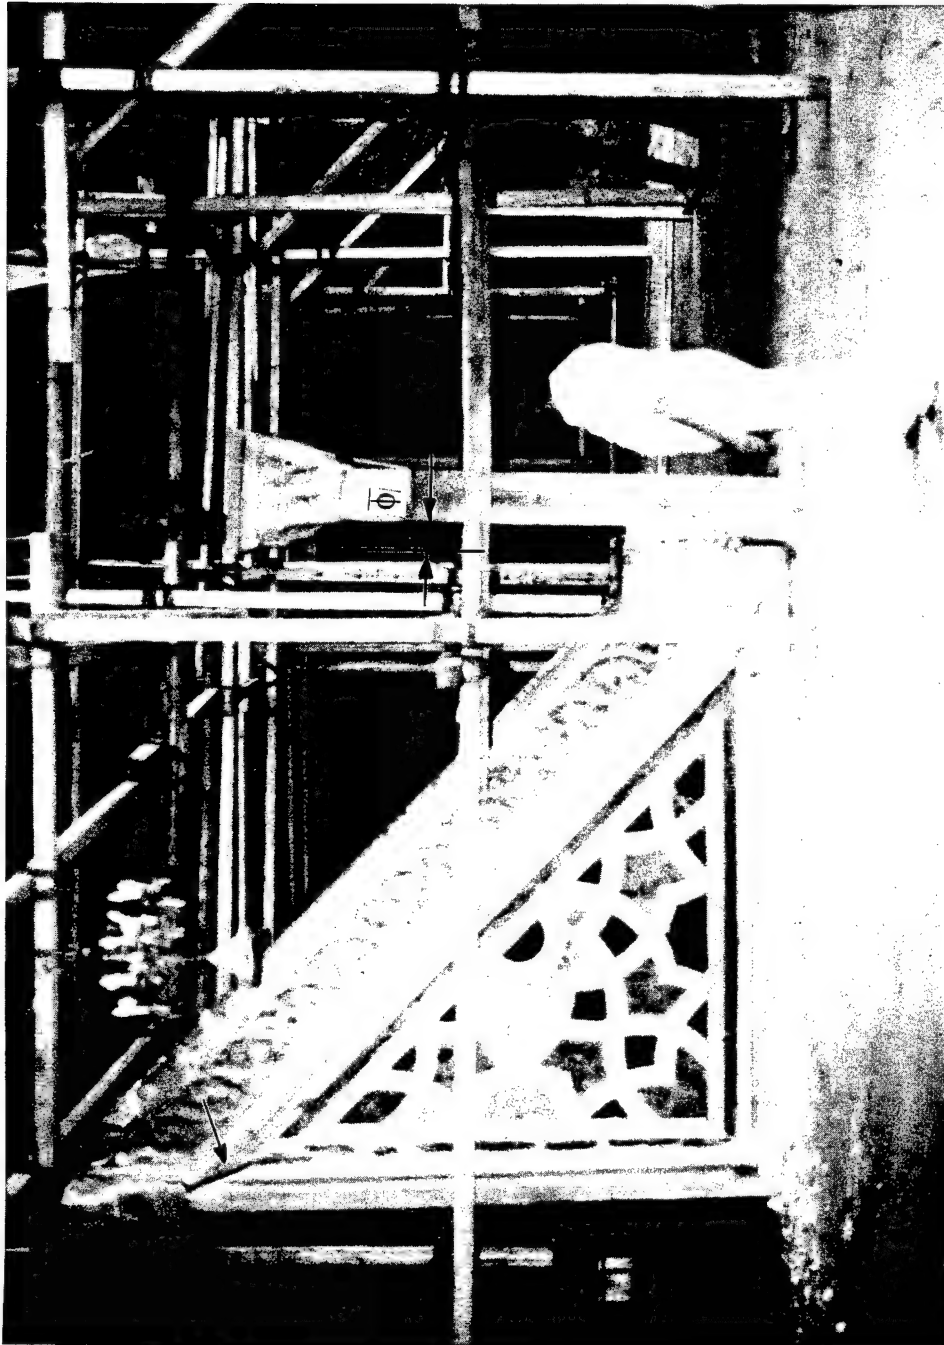
**FIGURE 4-32** Minbar of Mosque of Ibrahim Āghā Mustahfizān showing signs of relative displacement

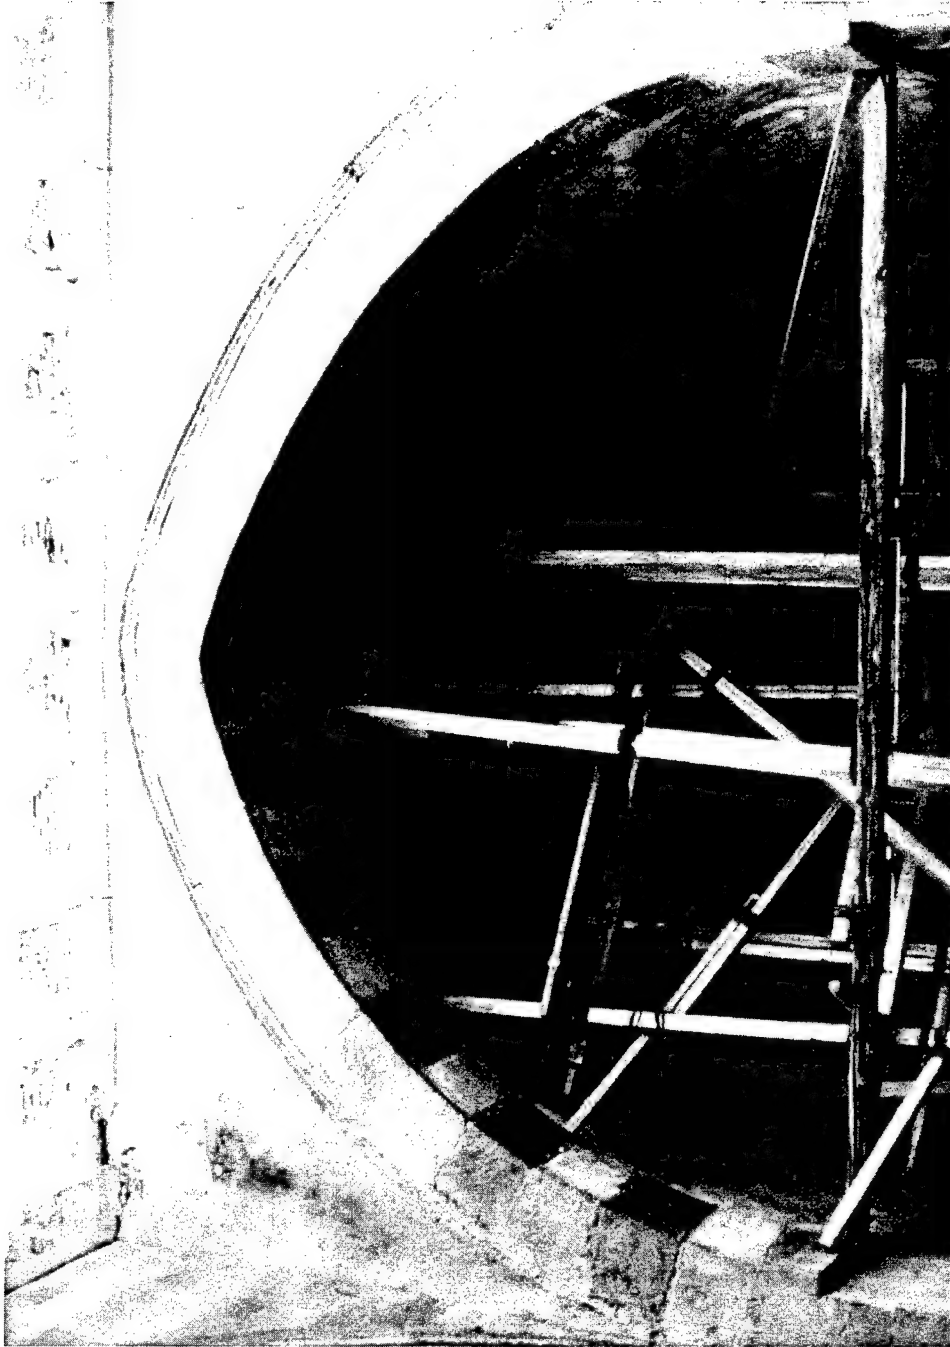
**FIGURE 4-33 Arch at Mosque of Ibrāhīm Āghā Mustahfizān showing cracks and bracing**

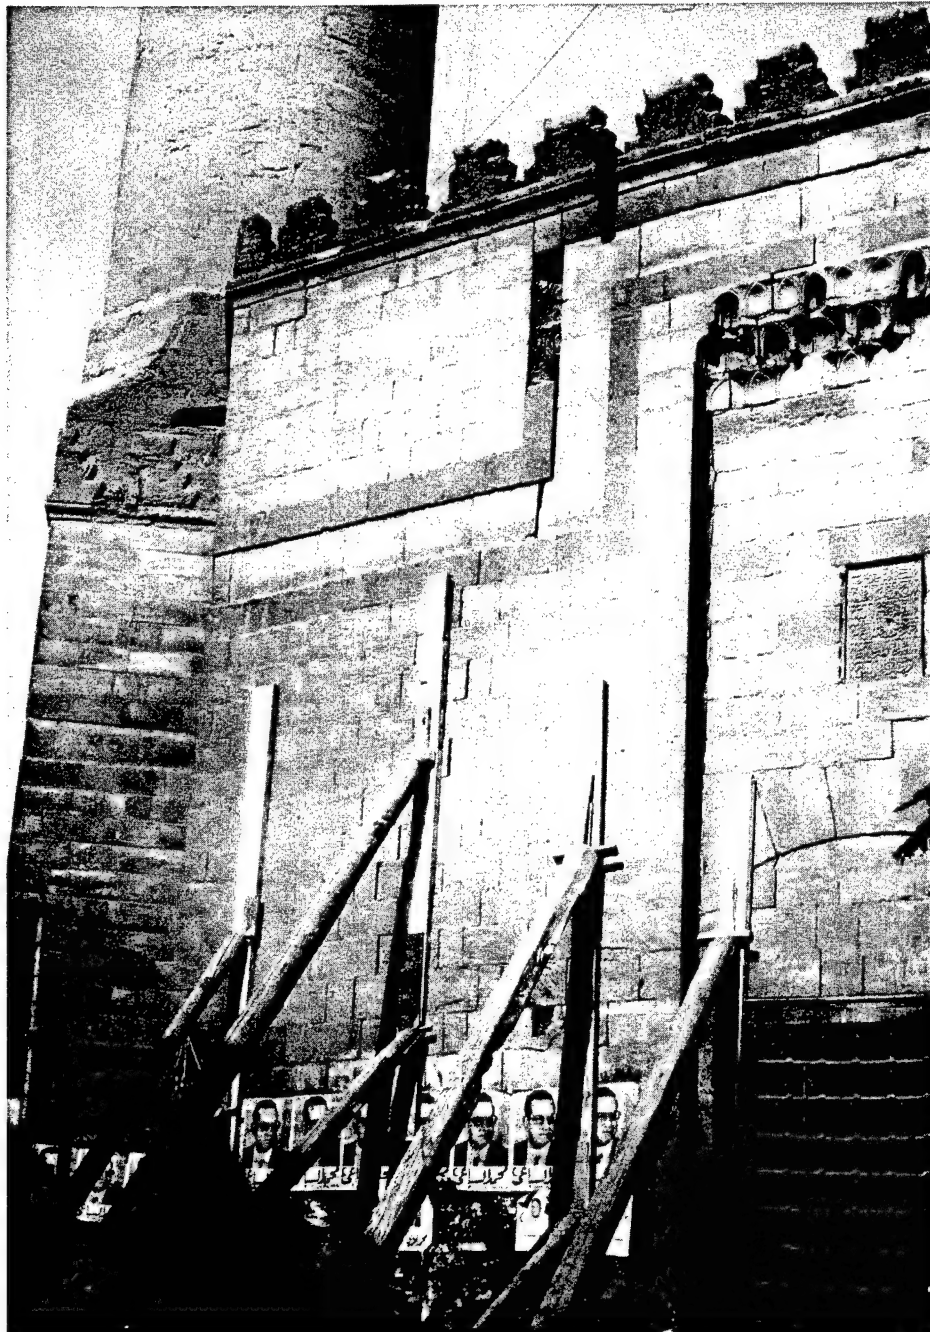
**FIGURE 4-34.** Exterior wall and base of minaret at Mosque of Ibrāhim Aghā Mustahfizān looking northeast showing cracks, distortions, and bracing

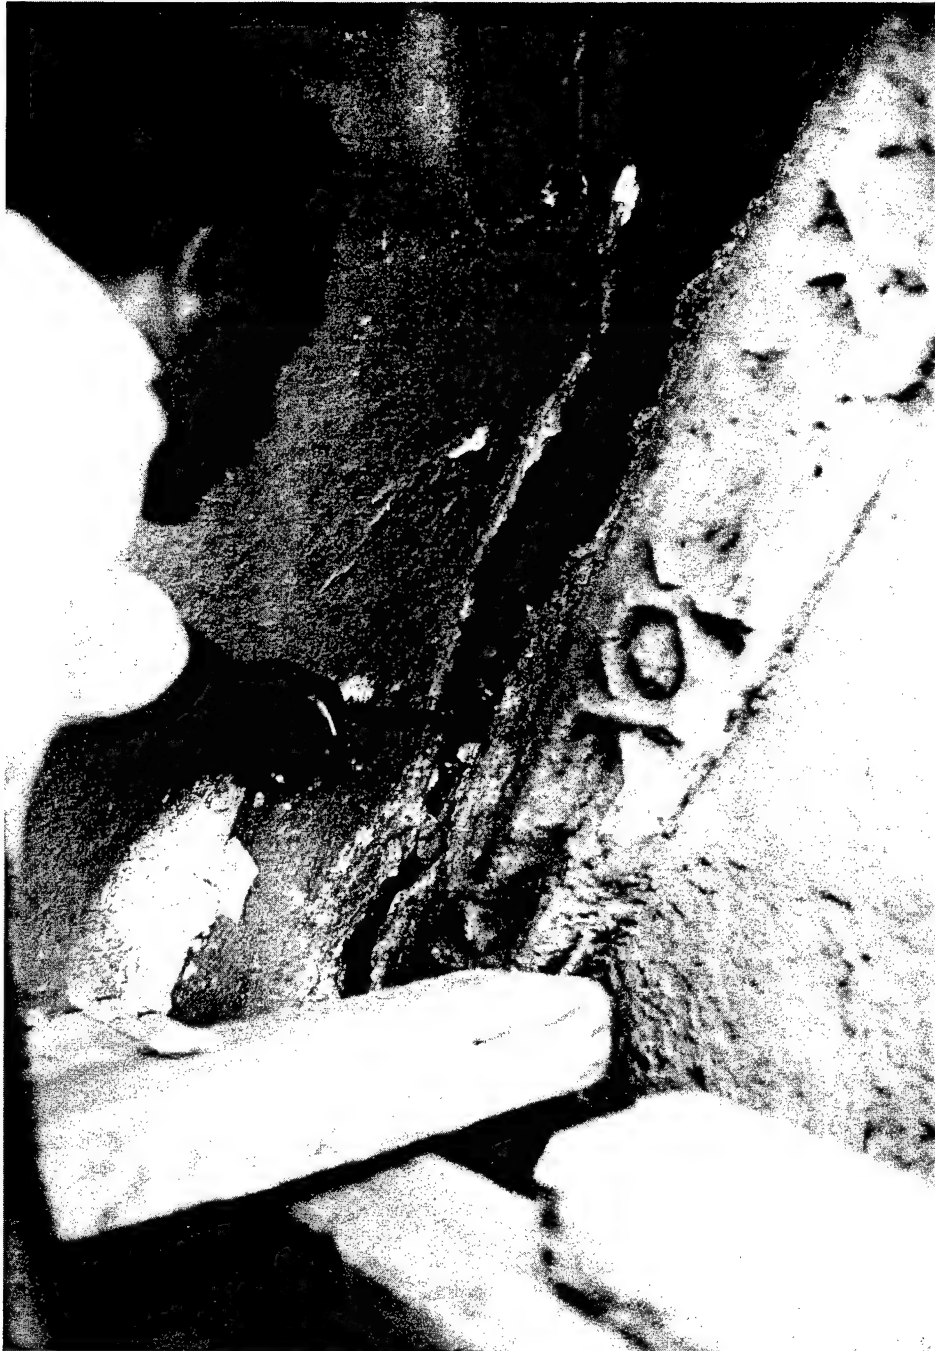
**FIGURE 4-35** Base of minaret at Hasan Pasha Tâhir Mosque  
showing separation between mosque and minaret

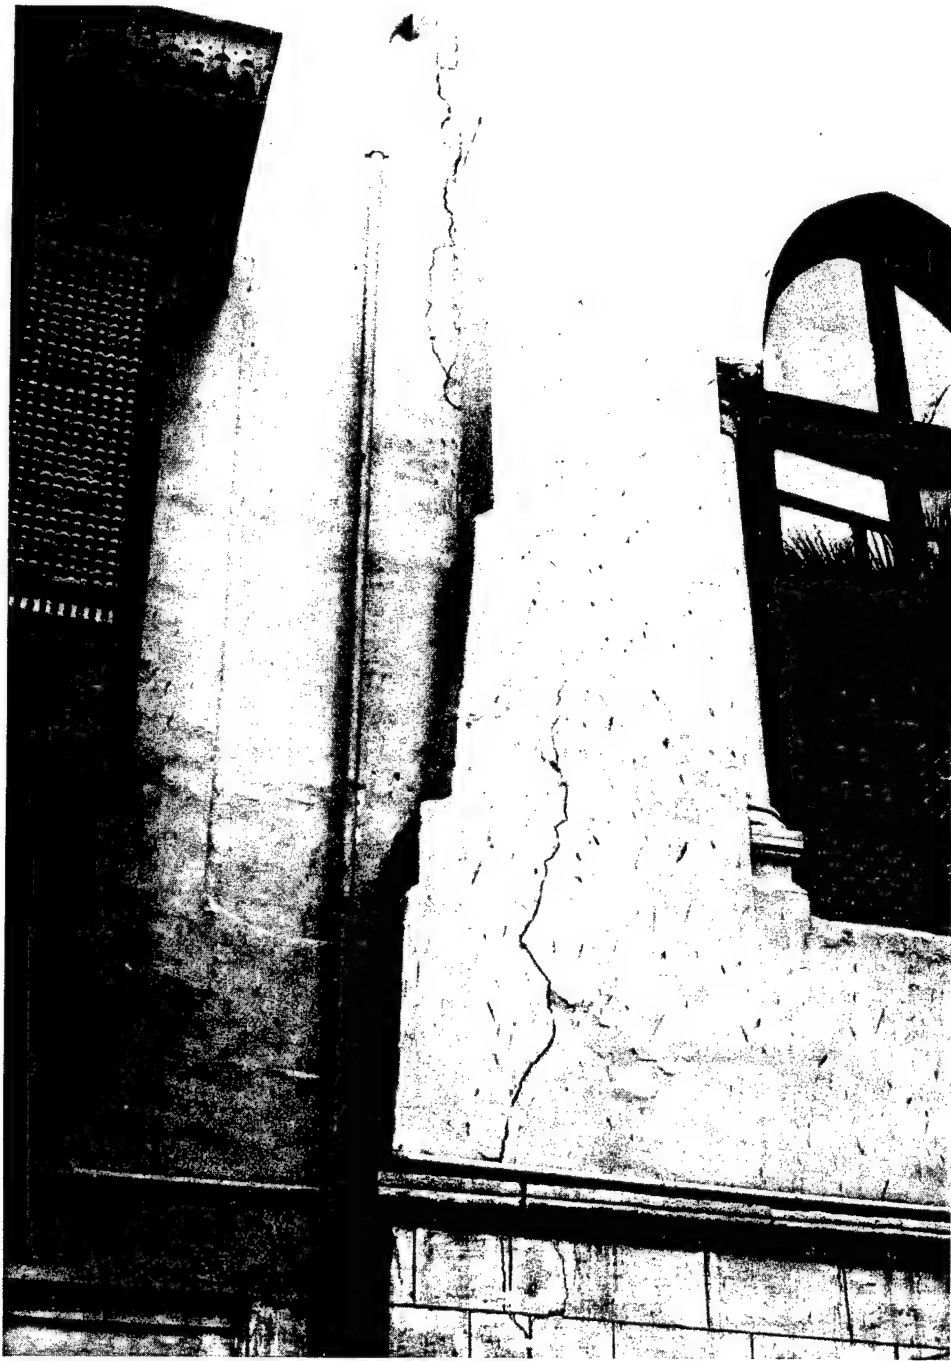
**FIGURE 4-36** Exterior wall of Coptic Museum looking north  
showing large cracks

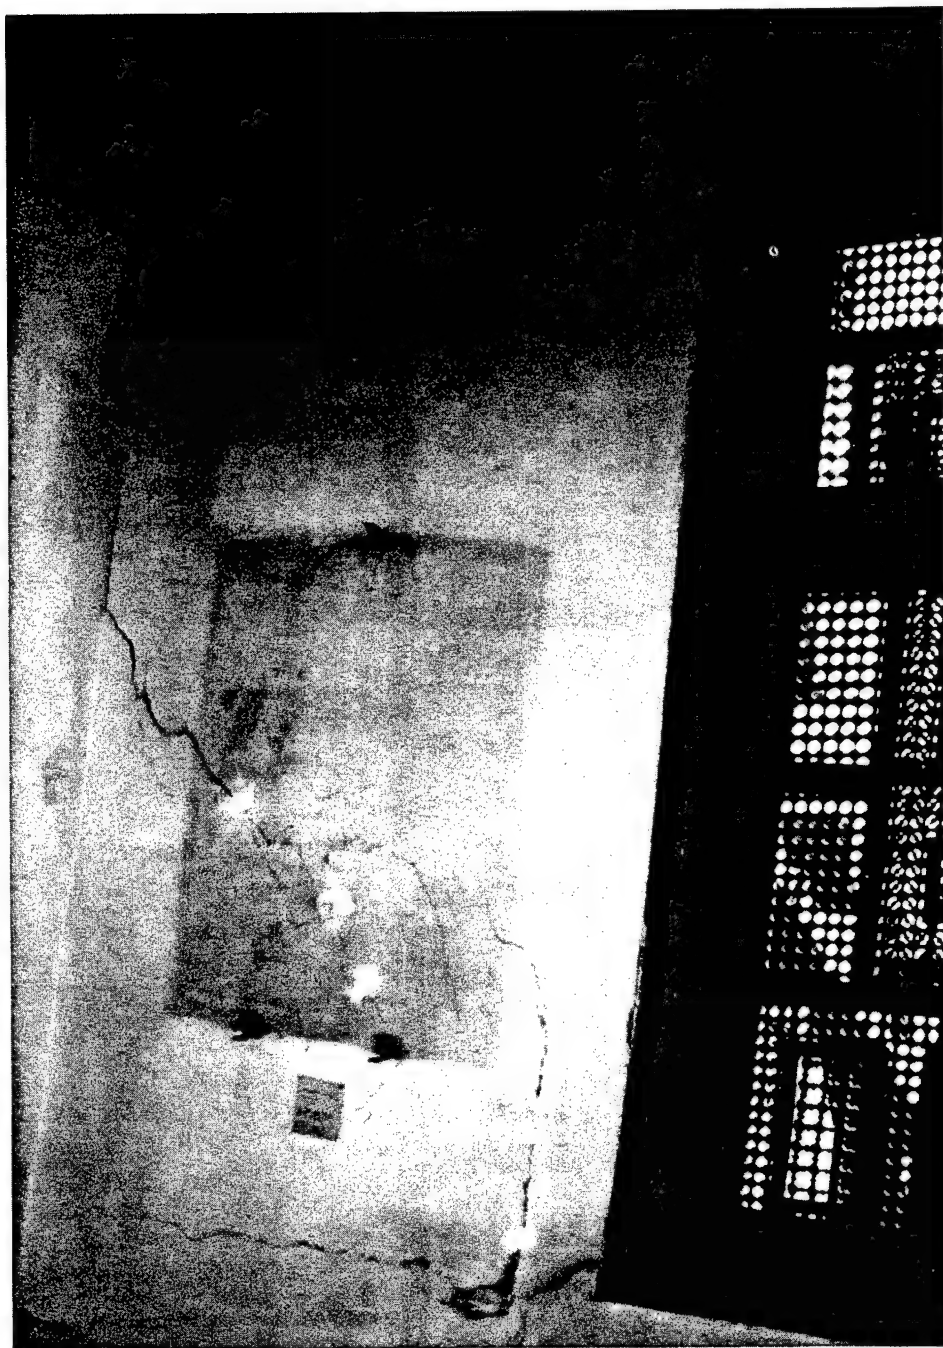
**FIGURE 4-37** Interior wall of Coptic Museum showing large cracks

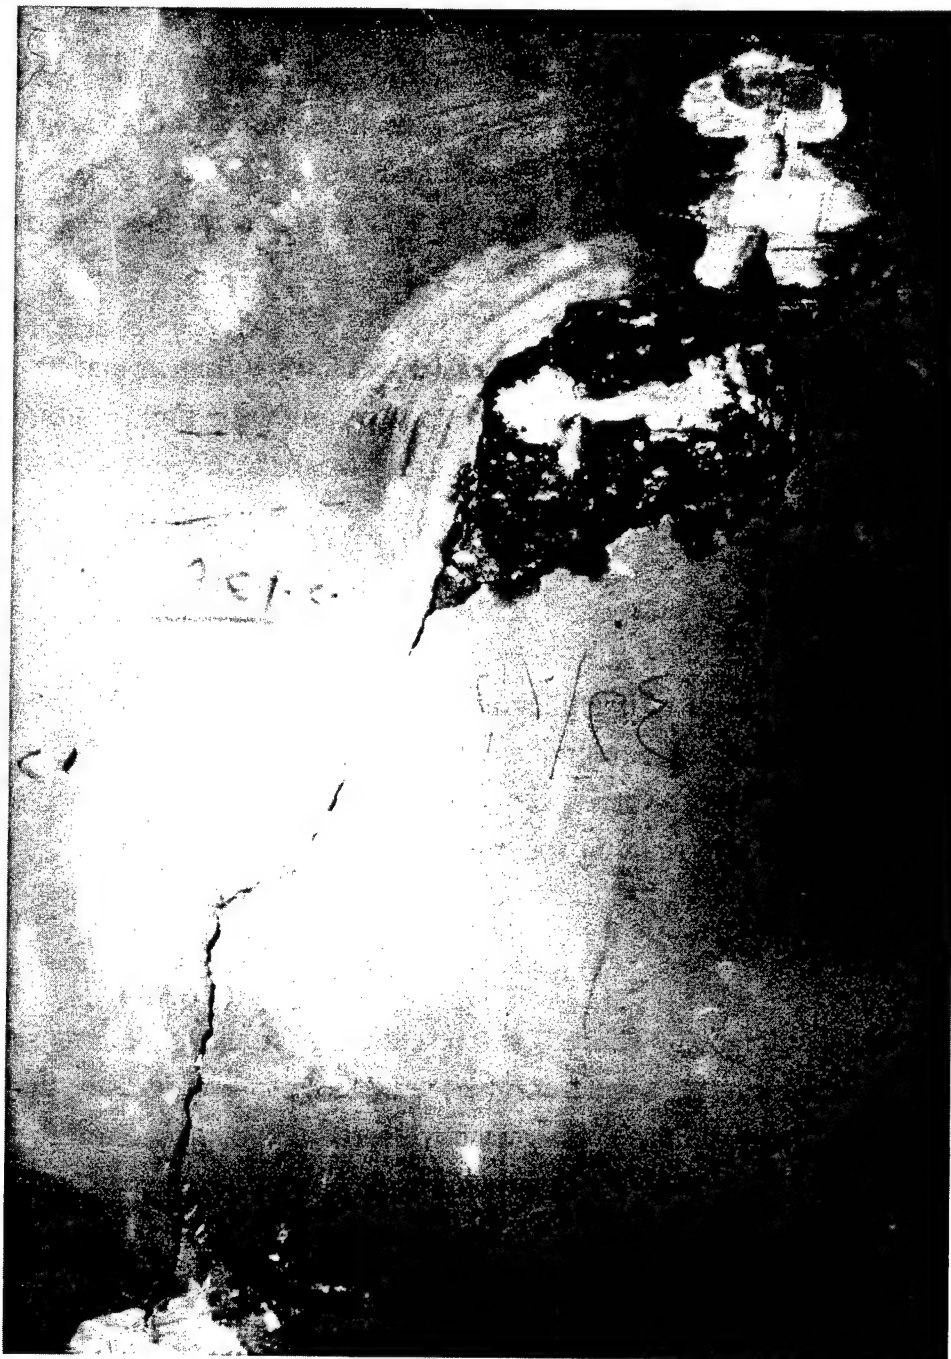
**FIGURE 4-39** Interior wall of el-Moalloqa Church showing cracks and deformations

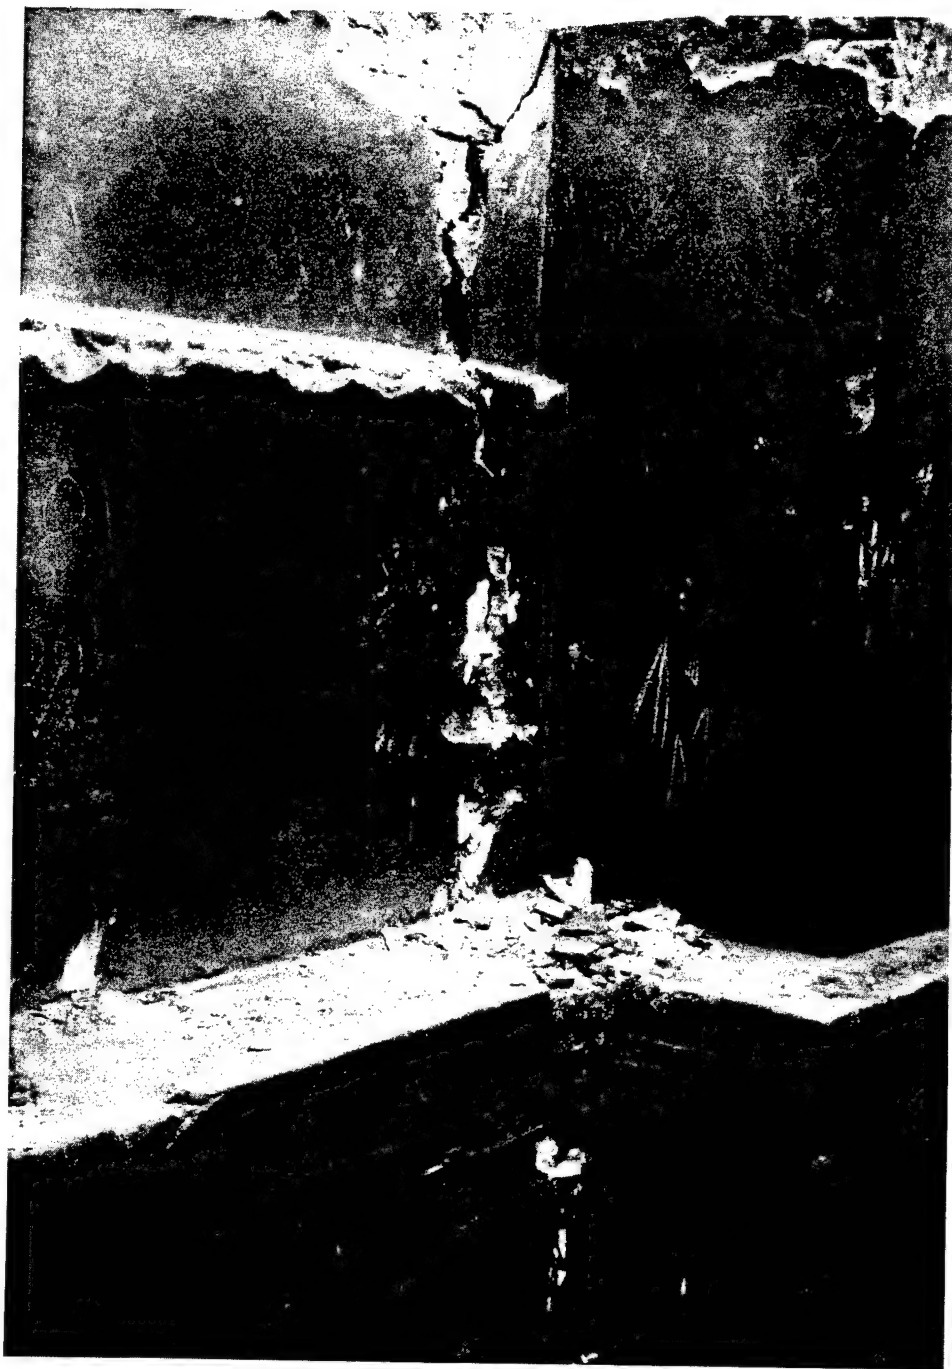
**FIGURE 4-41 Northern parapet wall of el-Moalloqa Church  
looking east showing cracks and deformations**

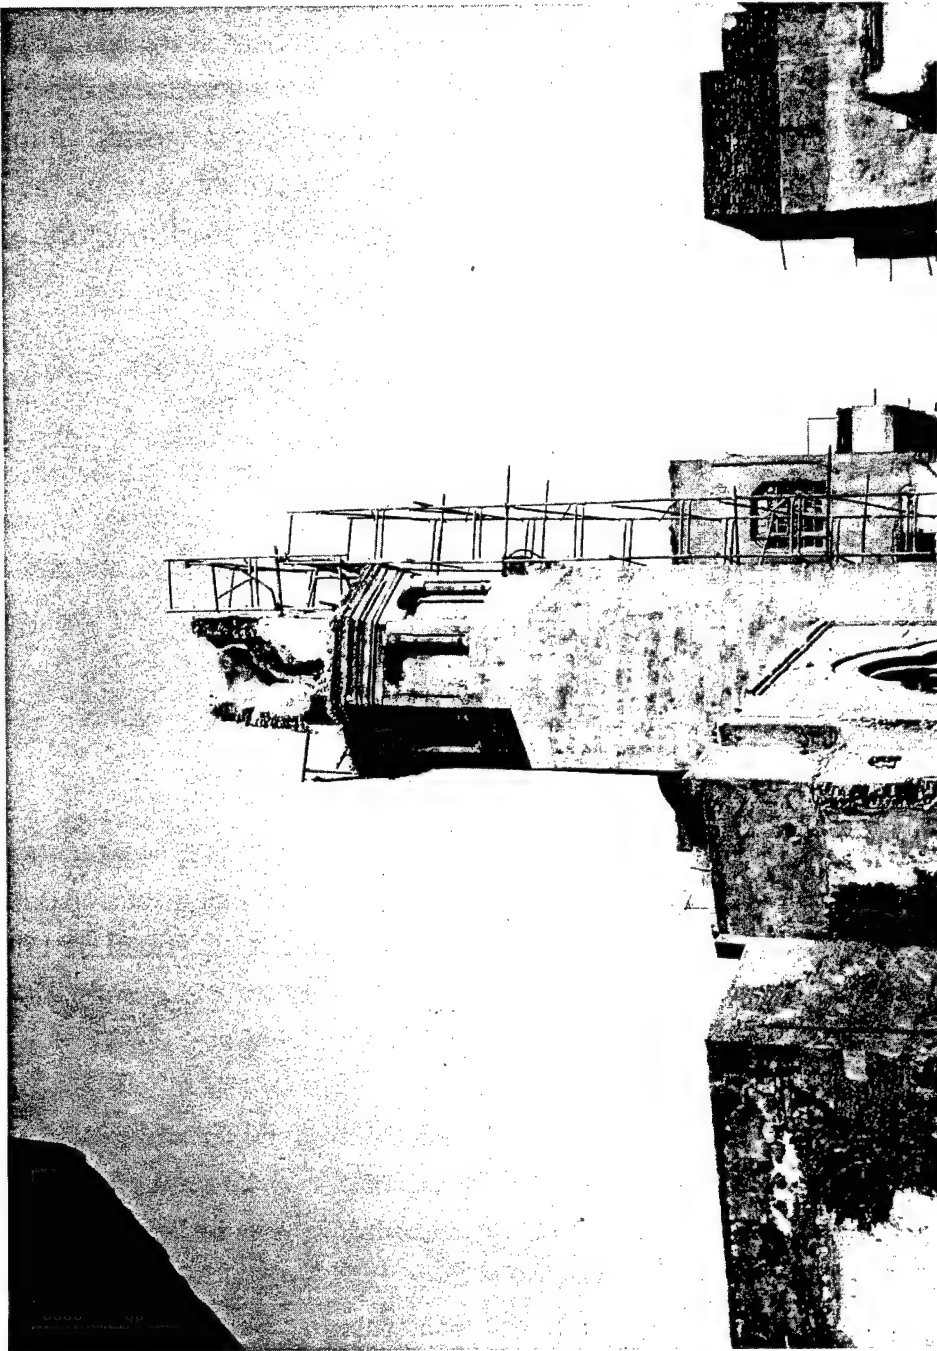
**FIGURE 4-42** Broken minaret of as-Saghir Mosque looking east

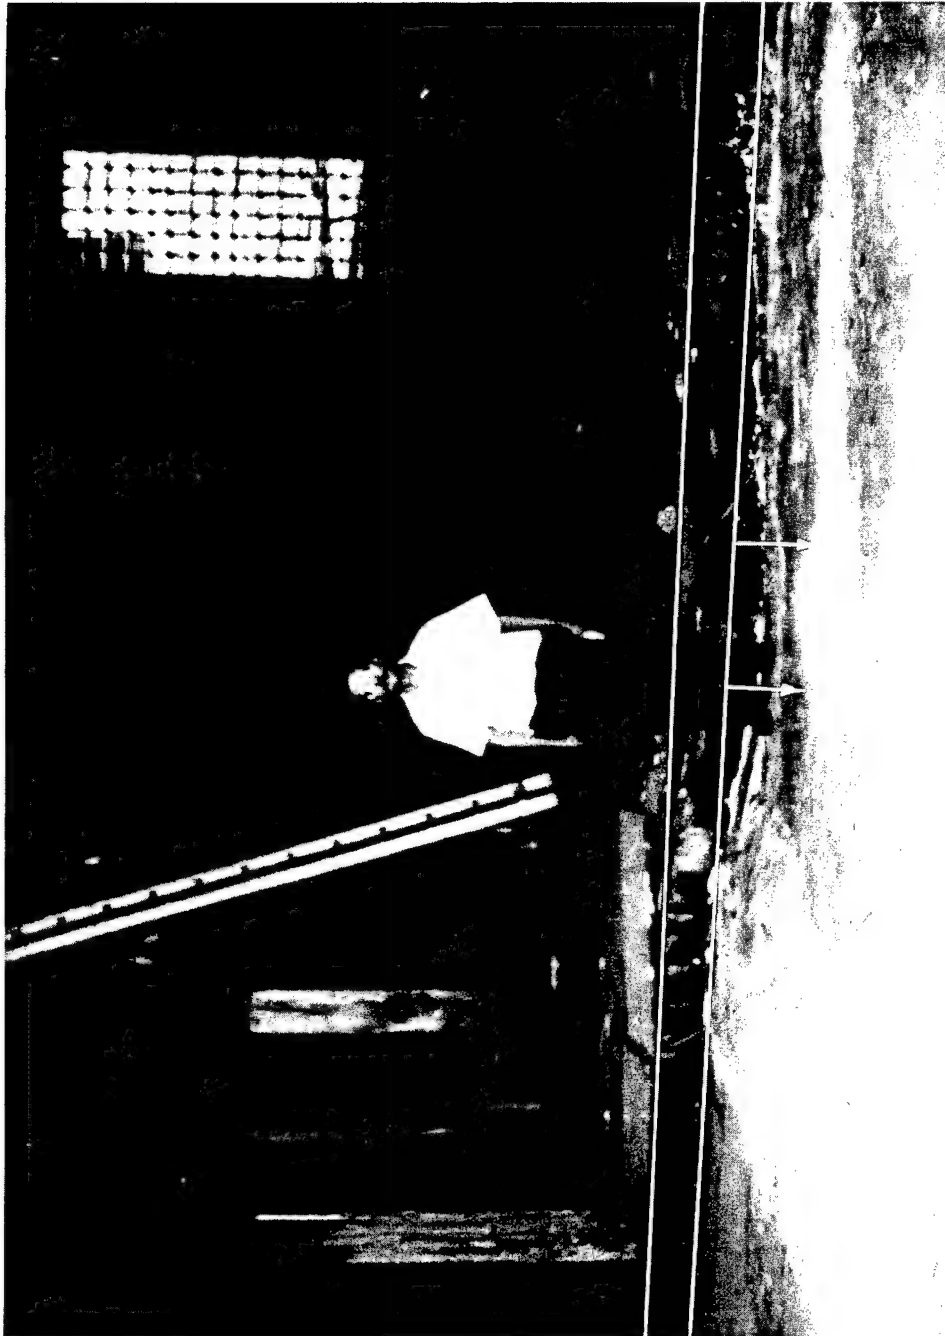
**FIGURE 4-43 Floor of Mosque of al-Ghūri looking southwest showing depression**

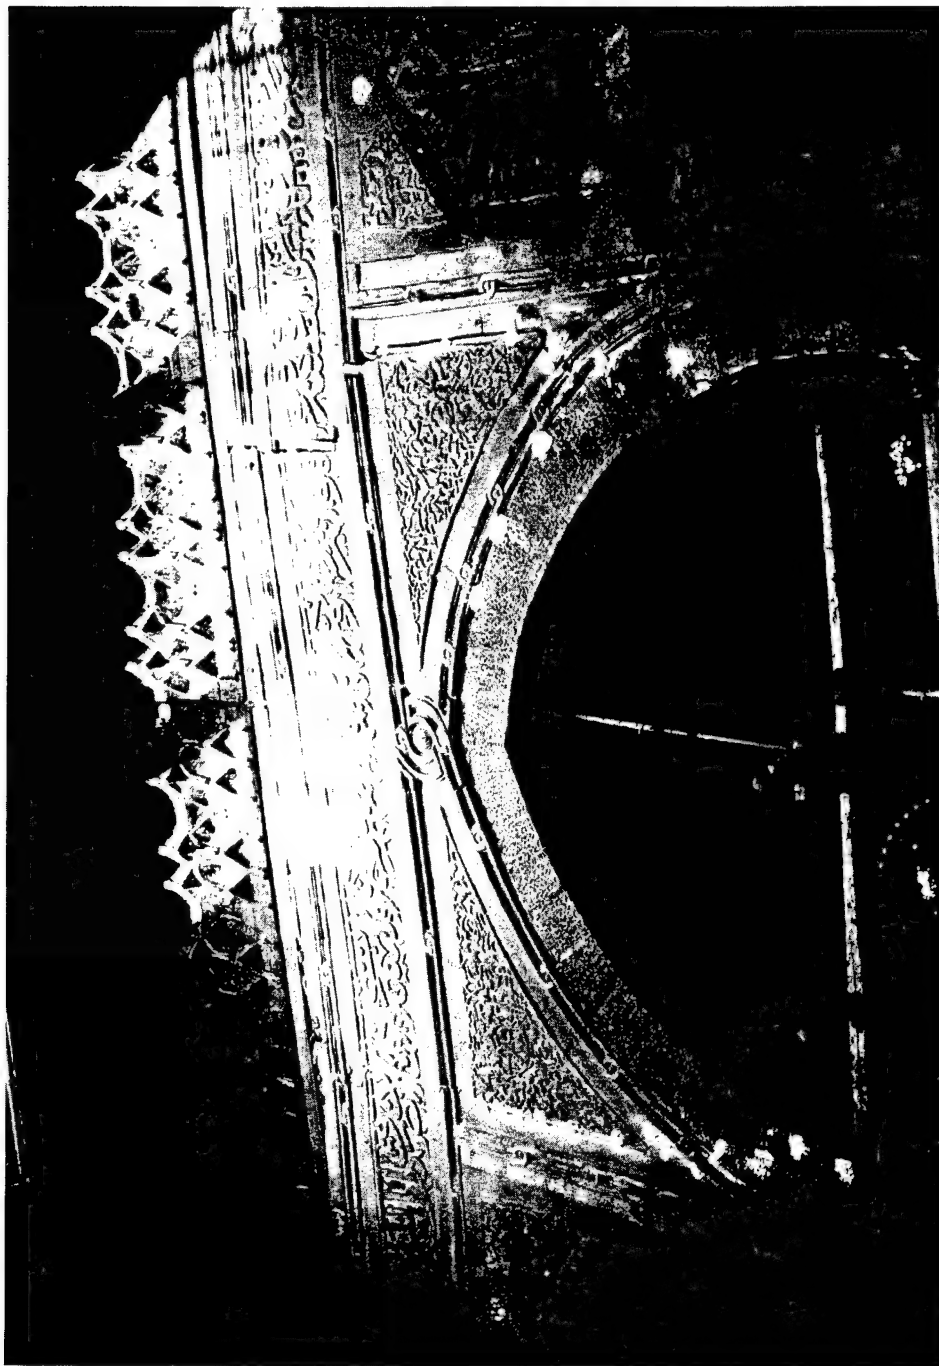
**FIGURE 4-44 Main arch of Mosque of al-Ghūri looking northwest showing cracks and distortions**

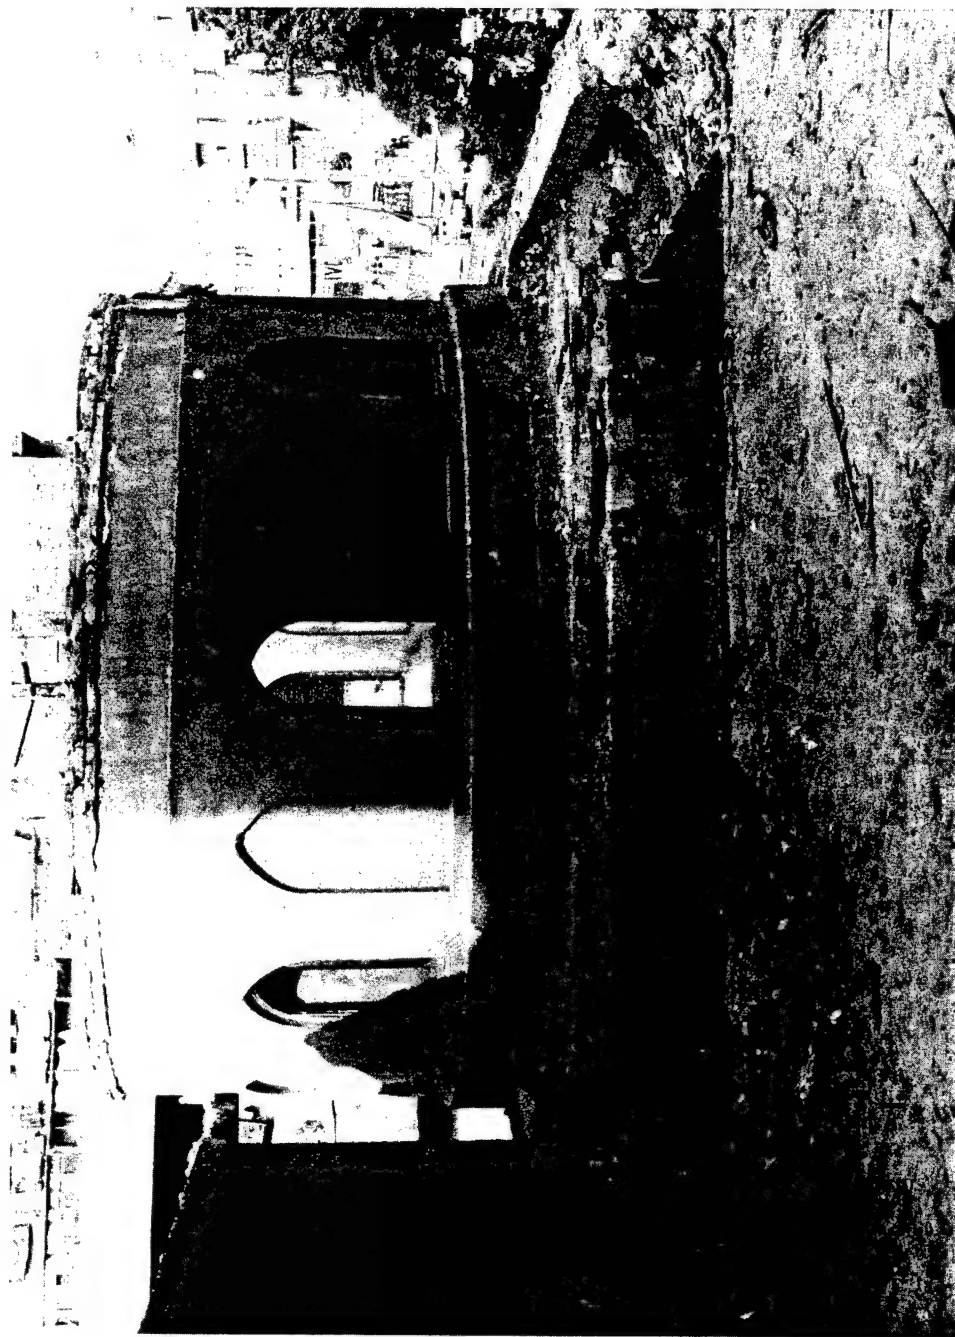
**FIGURE 4-45** Collapsed dome of ad-Dashtūti Mosque looking southwest  
showing damage to roof
